Ultrasonic and thermographic fatigue monitoring on a full-scale CFRP aeronautical component after repairing

V Dattoma¹, R Nobile¹, F Palano², F W Panella¹, A Pirinu¹, A Saponaro^{1,*}

Abstract. The identification of defects in real components made in composite material assumes considerable importance in the aeronautical field, as irregularities in the material can compromise its functionality. Also, the possibility (NDT) to verify the effectiveness of repairing on the component during exercise through non-destructive testing techniques has great importance.

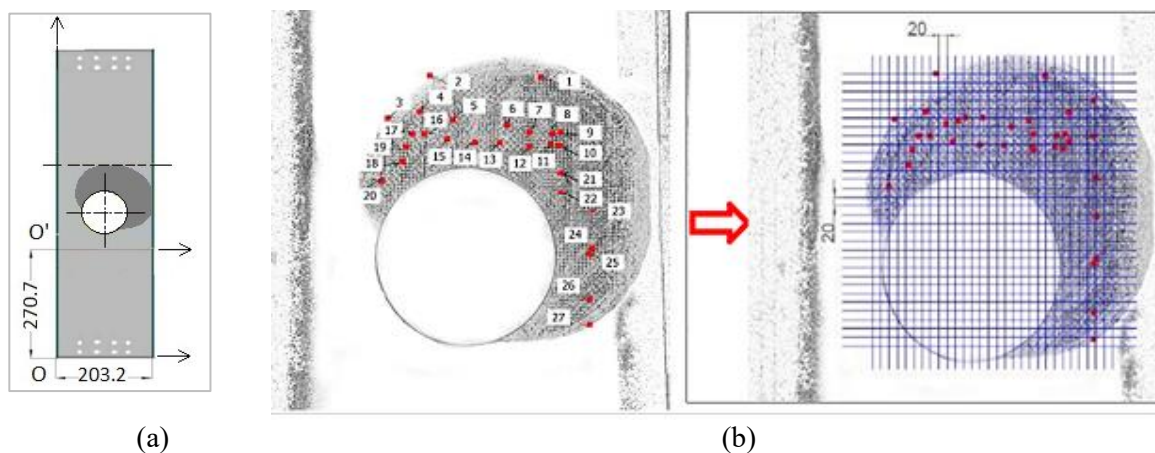
Figure 6. Absolute and relative coordinate system (a); Defects detected with the grid of inspection lines near the patch around the hole (b).

The position of the potential defects detected in the relative reference system was subsequently associated with an absolute coordinate system taking into account the real dimensions of the component, as seen in Figure 6a. Twenty-seven defects have been identified at different depths between 0.7 and 2 mm, which can be characterized as micro-delaminations and voids in the patch. Figures 7 and 8 show some examples of defects found on the spar and marked in red.

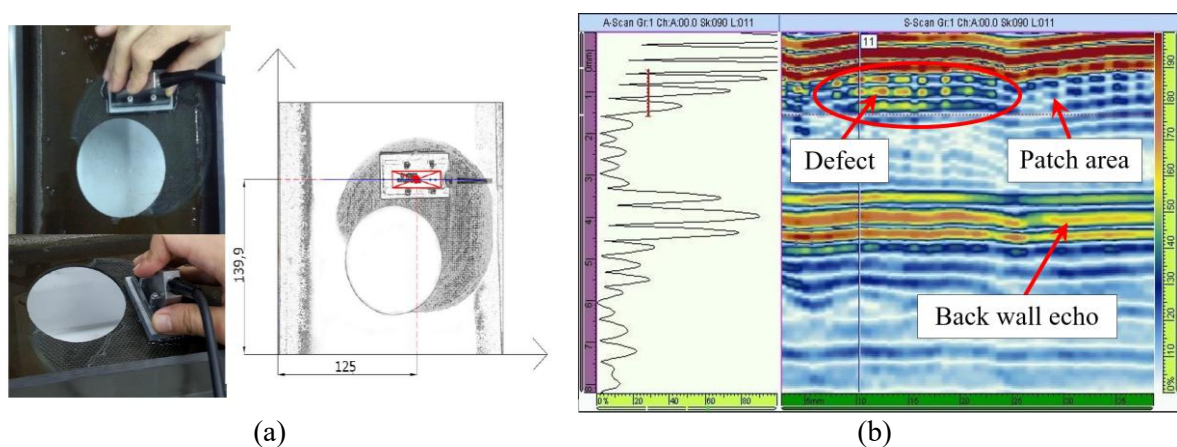
Figure 7. (a) A-scan and S-scan (0°) for defect 6 and (b) A-scan and S-scan (0°) for defect 7.

The characterization of the detected defects was performed by recording the value of the amplitude, defined as the ratio between the defect's amplitude and that of the background echo, and the depth data, both obtained from the A-Scan. The advantage of the phased array probe lies in the immediate achievement of the sectorial scan that allows to better evaluating the shape of the defect compared to conventional probes. Table 2 summarizes some of the main significant defects found on the spar's repair.

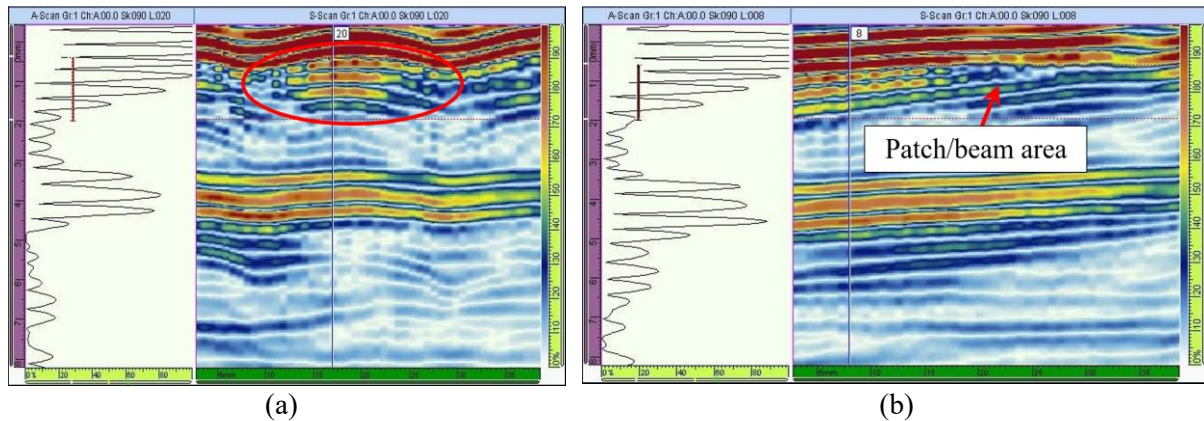
Figure 8. A-scan and S-scan (0°) for defect 7 (a) and defect 11 (b).

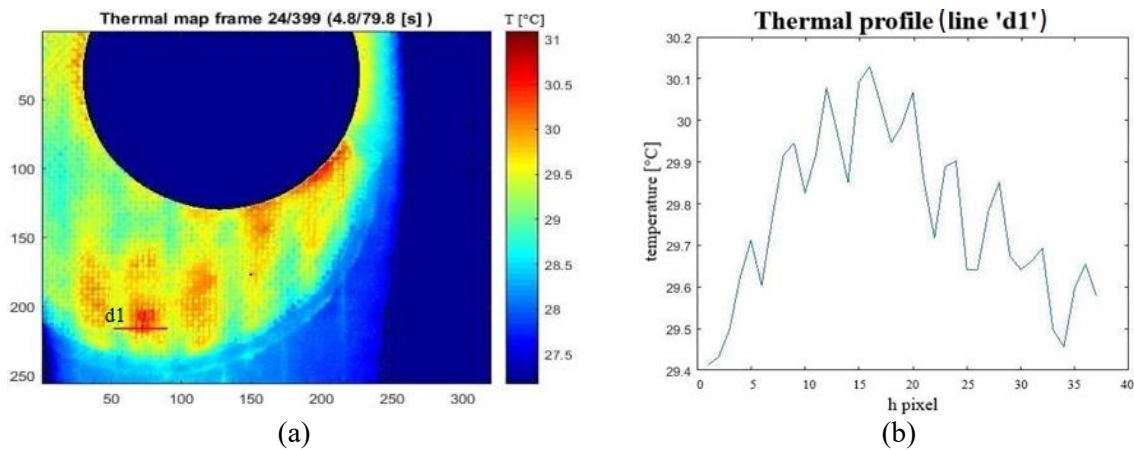
A qualitative thermal profile along the line 'd1' is selected in the thermogram of maximum heating time, as seen in Figure 9a; along the example thermal profile of Figure 9b, the temperature data show a curve variation around of 0.7 °C, detected symptomatic of the presence of defects.

Figure 9. (a) Thermal image employing a heating time of 5s; (b) thermal profile through the horizontal red line 'd1'.

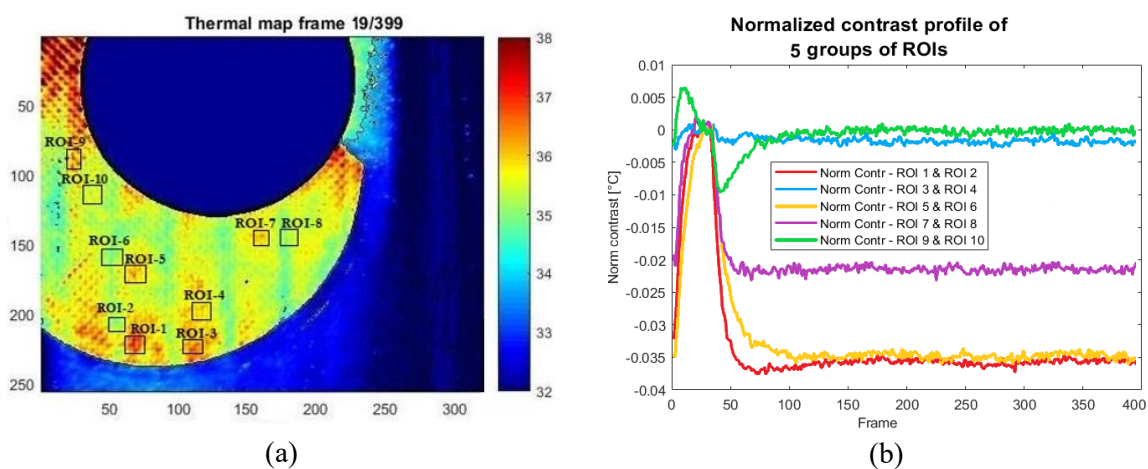
Figure 10. (a) Thermogram with selected ROIs employing a heating time of 3s; (b) normalized contrast profile of selected ROIs.

Specifically, the odd numbers ROIs indicate the defective regions, while the near even numbers indicate the relative intact areas for the normalized contrast's calculation. Subsequently, the Matlab routine provides the normalized contrast diagrams of ROIs obtained during the thermal acquisition, as shown in Figure 10b for the chosen ROIs. Contrast profiles present similar trends tending initially towards zero at the maximum heating time (at 19th frame in this case) and then decreasing trend up to a constant equilibrium phase. The ROI-1 could be identified as the defect-1 by UT, although the other sub-superficial ROI-3, ROI-5 and ROI-7 defects seems not associable with previous detected defects.

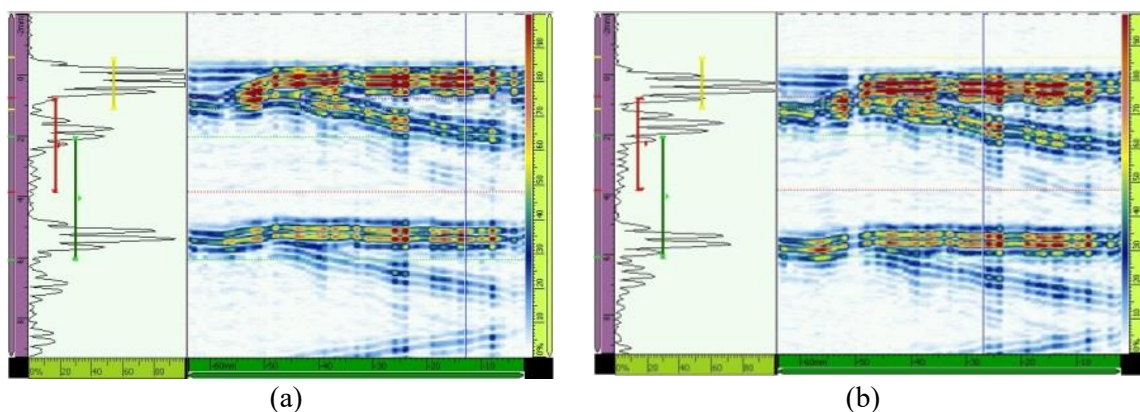
It was possible to detect the presence of geometric irregularities of the patch surface and the absence of defects inside it and to verify the adhesion of the patch in service conditions.

The irregularities reported could be the result of the production process of the beam or of the same material of which the patch is made. Figure 11 show as an example the ultrasound results relating to sector N $^\circ$ 5 for each step of the fatigue test.

Figure 11. Phased array results (A-scan and S-scan (0°)) at different fatigue cycles on the sector monitored N $^\circ$ 5. (a) 2000 cycles and (b) 60000 cycles.

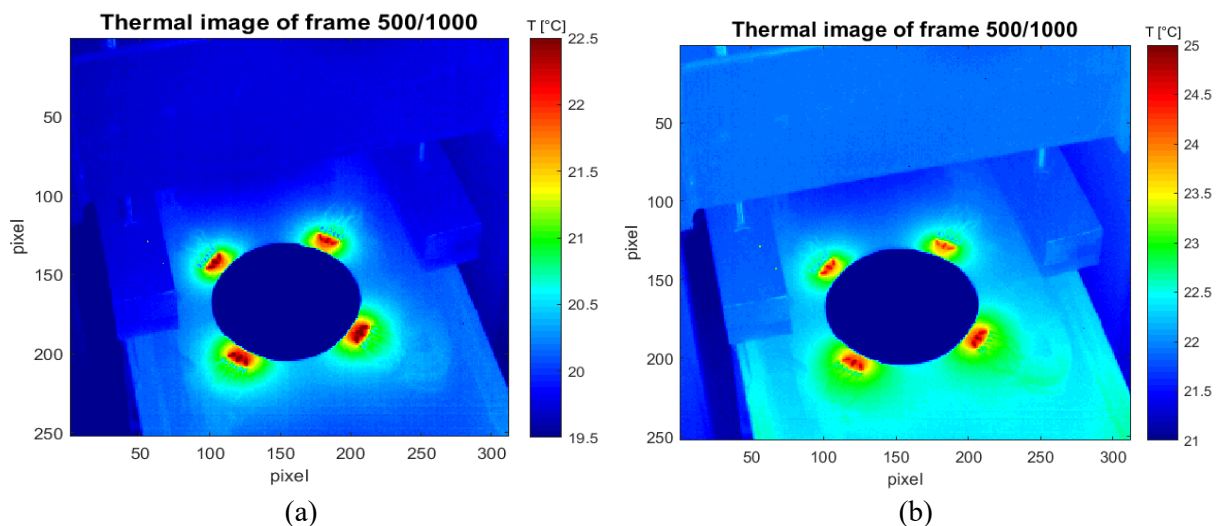
Figure 12. Thermographic analysis of one loads' block at 3000 cycles (a) and 90000 cycles (b) on the monitored sector.

The thermal evaluation gives unsatisfactory information of internal spar structure and defective areas were not detected during fatigue test even after load cycles. As expected, the average temperature of the spar scarfing zone first undergoes a slow increase, then stabilizing around a constant value (Figure 12b).
